Appendix P  
Photos  
Picnic Facilities

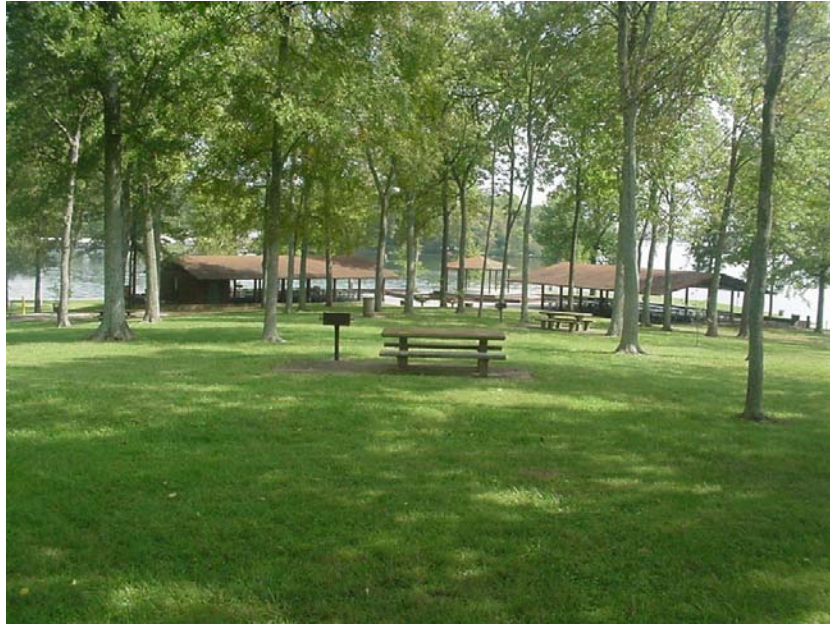
Photo P-1. Plaza approach for picnic shelter placement. Rockland Recreation Area, Old Hickory Lake, TN. This example of a plaza approach combines multiple shelters and related amenities to serve large groups and extended family gatherings (Para. 3.4)

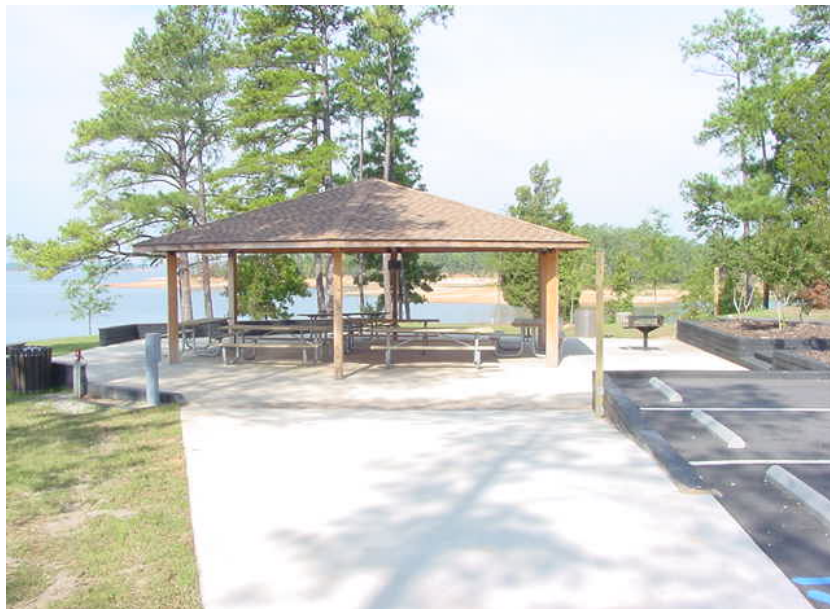
Photo P-2. Picnic shelter concrete pad. Clarks Hill Park, Hannah Point Shelter, J. Strom Thurmond Lake, SC. Note that concrete pad extends beyond the edge of the support posts for UA, and is sloped to drain away from the shelter (Table 3.2)

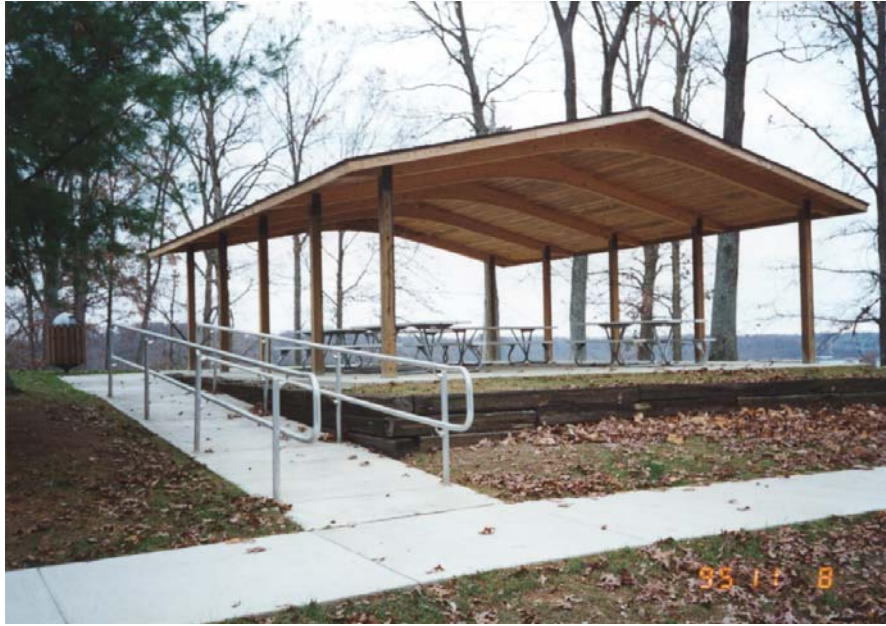
Photo P-3. Picnic shelter roof trusses. Overlook Area, Monroe Lake, IN. Note that roof trusses do not allow birds to roost or build nests (Table 3.2). This shelter constructed from a prefab kit. Also note railings incorporated on sidewalk for UA

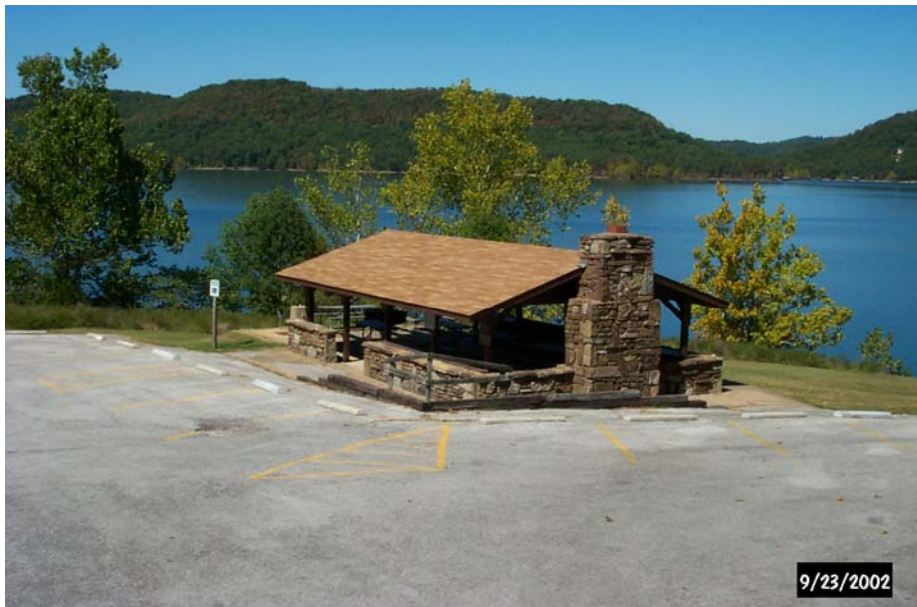
Photo P-4. Picnic shelter parking. Starkey Park, Beaver Lake, AR. This shelter has convenient parking that accommodates UA and loading and unloading of supplies. Also note placement with a scenic lake view (Table 3.2)

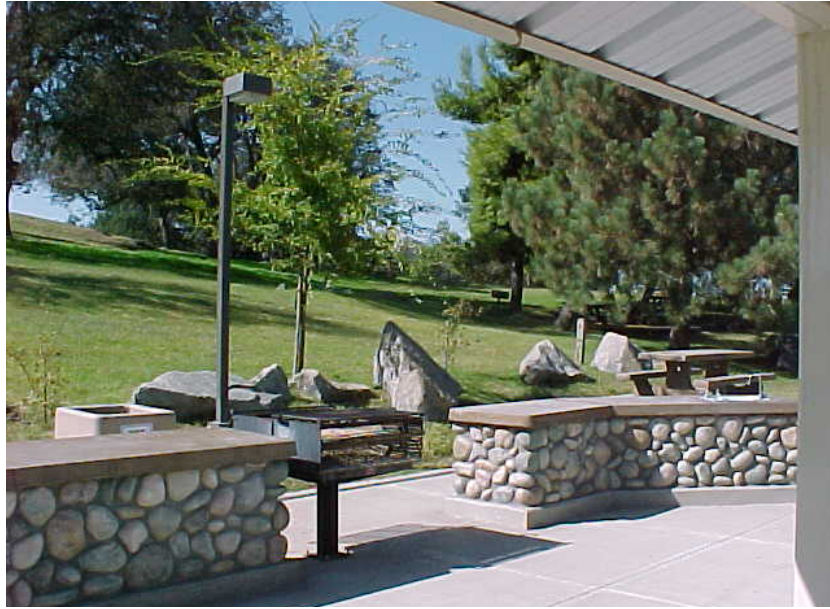
Photo P-5. Picnic shelter features, View 1. Millerton State Park, CA. Concrete pad extends beyond shelter for UA. All surfaces designed for pressure washing. Group size grill, long utility table with GFCI outlets, and nightlight provided. French drain included (visible adjacent to grill) (Table 3.2)

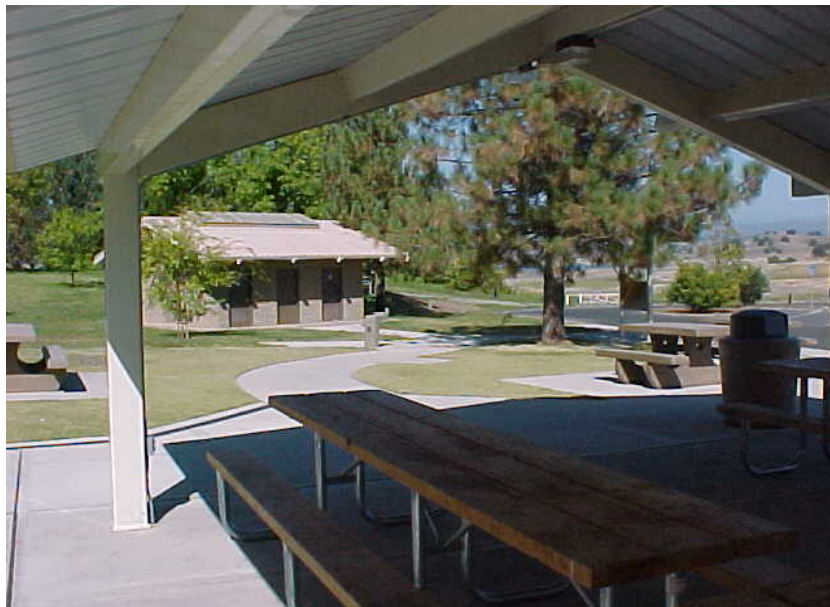
Photo P-6. Picnic shelter features, View 2. Millerton State Park, CA. Shelter is UA. Convenient to restrooms, water fountain, trash receptacle, and GFCI outlet visible on post (Table 3.2)

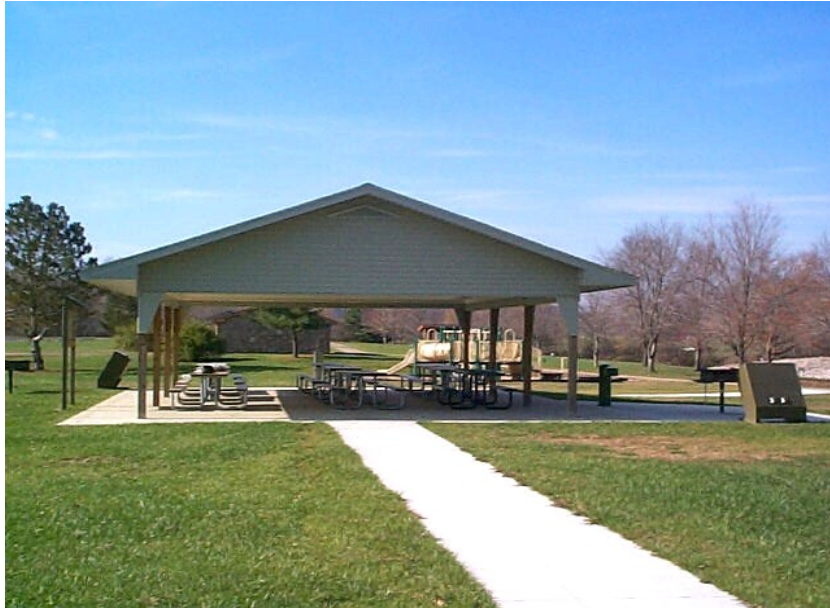
Photo P-7. Picnic shelter features and amenities, View 1. Cave Run Lake, KY. Shelter is UA, has concrete apron, and is convenient to restroom and playground equipment (Table 3.2)

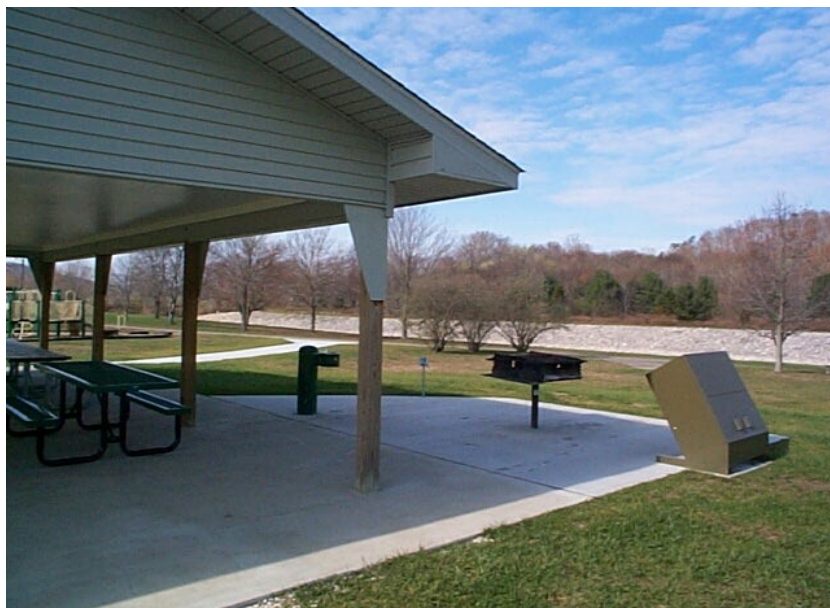
Photo P-8. Picnic shelter features and amenities, View 2. Cave Run Lake, KY. Shelter has low-maintenance vinyl siding at gable ends. Extended concrete apron accommodates UA grill, UA drinking fountain, and garbage containers with UA (side opening) doors (Table 3.2)

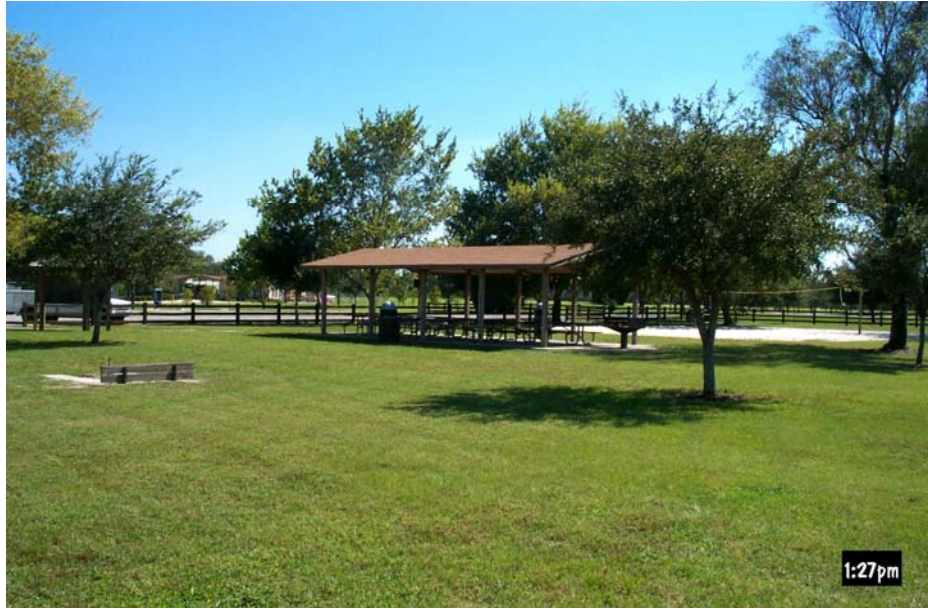
Photo P-9. Picnic shelter amenities. W.P. Franklin South Recreation Area, Okeechobee Waterway, FL. This shelter area offers optional amenities of horseshoe pits (foreground) and a volleyball court (background) (Tables 3.2 and 5.13)

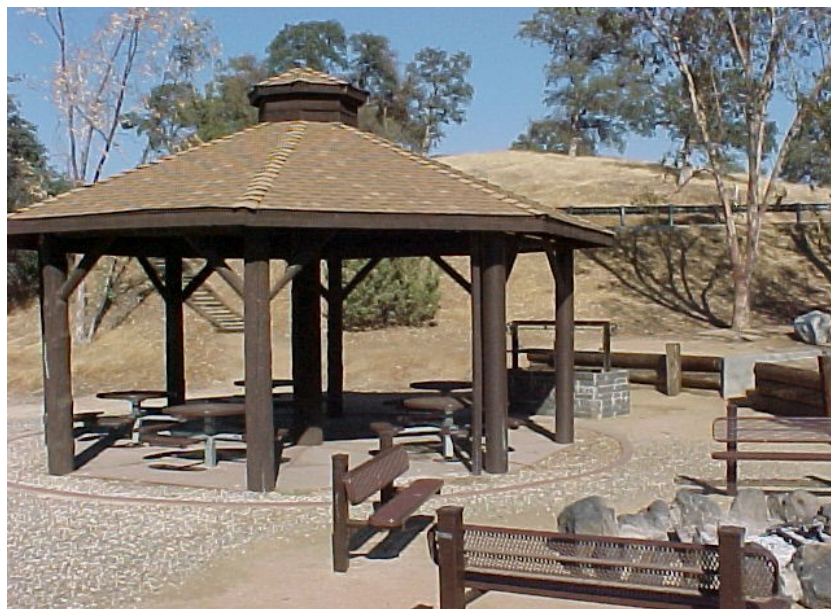
Photo P-10. Small shelter. Hensley Lake, CA. Shelter offers four tables, is totally UA, includes group fire area and benches, and group size grill (Table 3.2)

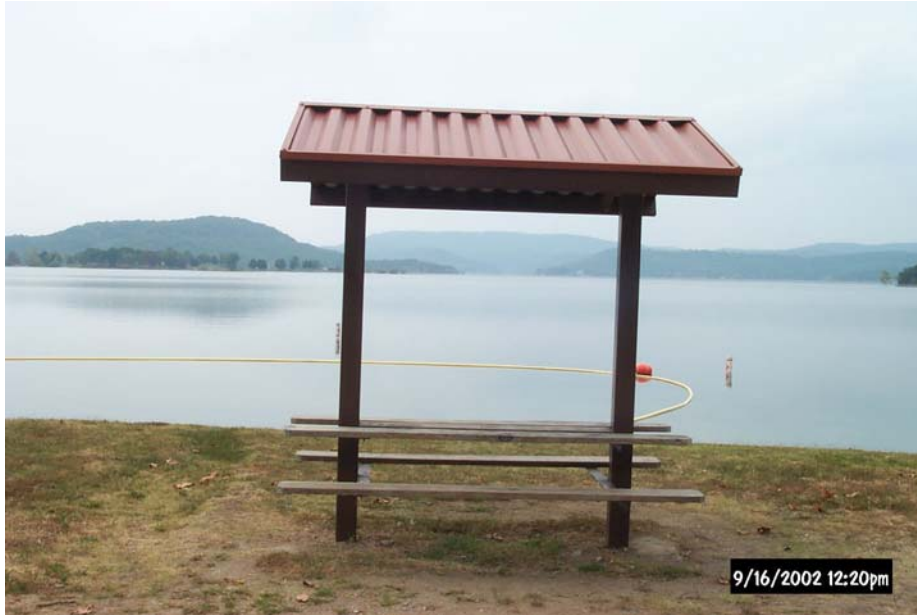
Photo P-11. Covered table. Starkey Park, Beaver Lake, AR. Shade structure constructed to provide shade for table (Table 5.13). Located in conjunction with other amenities, and in this case offers shaded seating that encourages adult supervision of swimming area (Table 5.12)

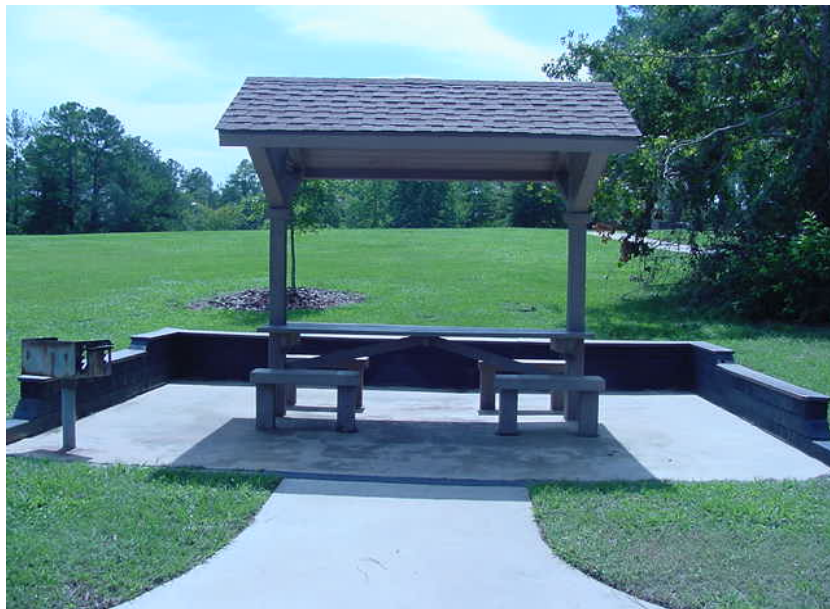
Photo P-12. UA covered table. West Dam Day Use Area, J. Strom Thurmond Lake, GA. Shade structure constructed to provide shade for table (Table 5.13). Note UA features: concrete walk and pad, and split bench design that allows wheelchairs or strollers to pull up to the table (Para. 5.2.1)

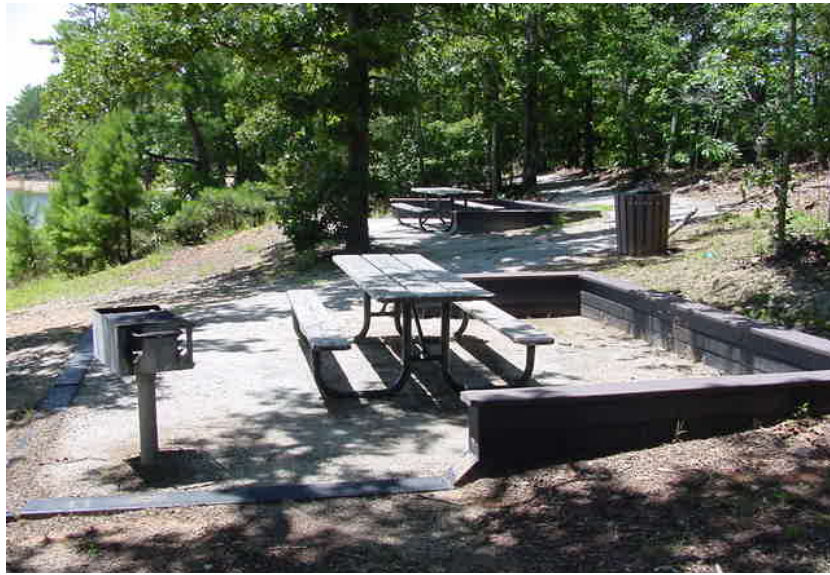
Photo P-13. Single picnic site. Lake Springs Day Use Area, J. Strom Thurmond Lake, GA. Table located on delineated impact pad (Table 4.1), includes shade, pedestal grill, and scenic view (Tables 5.13 and 5.14)

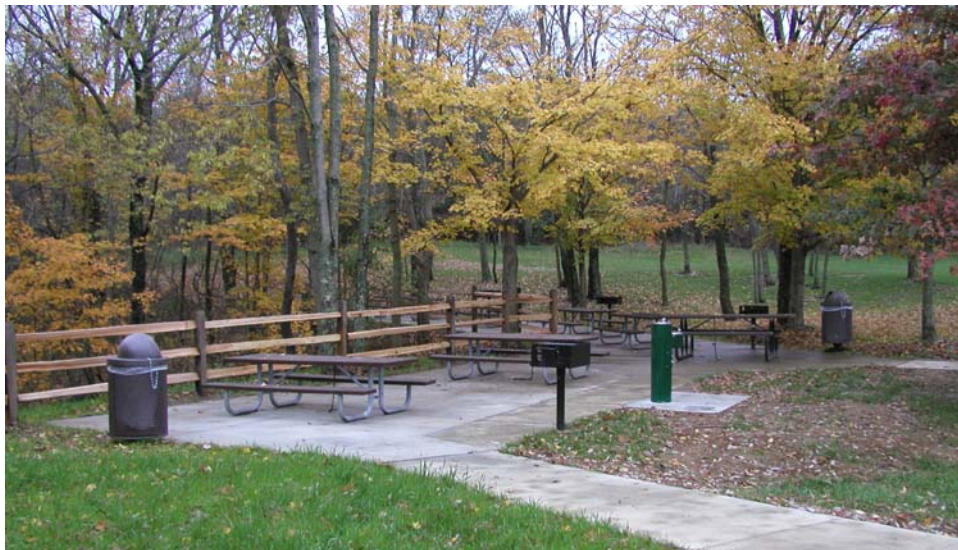
Photo P-14. Multi-table site. Overlook Area, Taylorsville Lake, KY. In addition to individual sites, groupings of picnic tables are recommended to accommodate customer demand. Note that water fountain, pedestal grills, garbage cans, and hardened surface are provided (Table 5.13)
